# Guide to Assessment and Repair of Flood Damaged Timber and Timber Framed Houses

(Revised 19<sup>th</sup> Jan 2011)

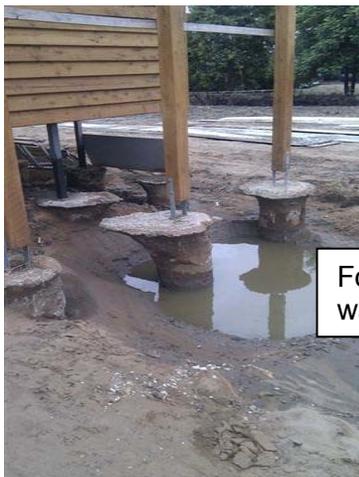
Footings scoured out by fast flowing water

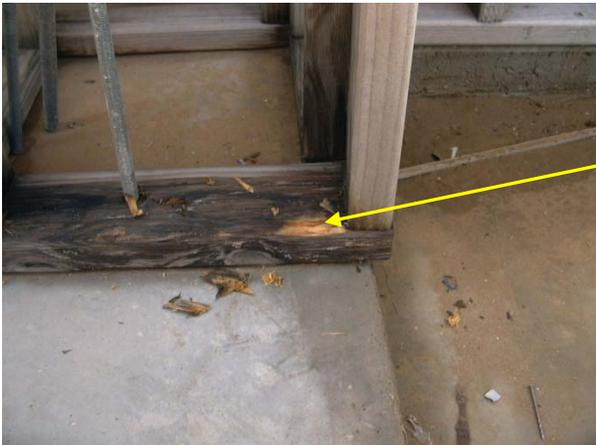
Although heavily discoloured with surface mould and blue stain, the pine timber is still sound as shown by scraping back the surface layer

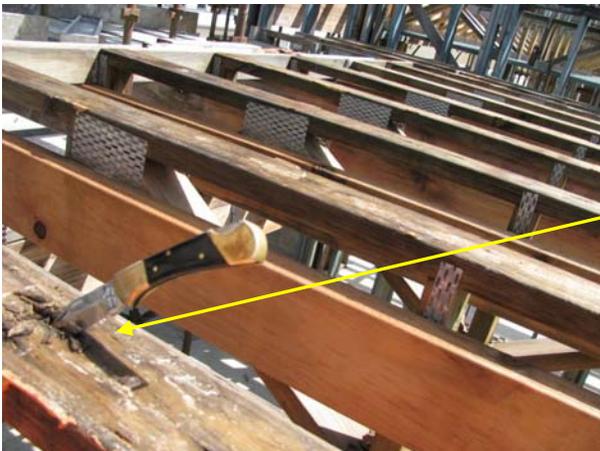
Decayed timber is soft and spongy and can easily be penetrated with a knife or screwdriver

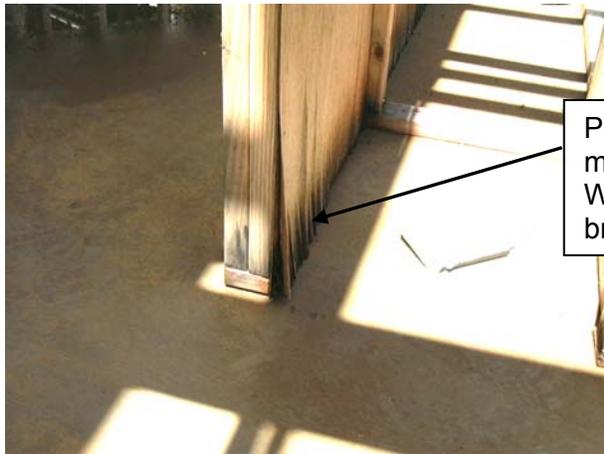
Plywood sheet bracing affected by moisture. Replacement required. Where necessary fix temporary braces.

In houses built after about the mid 1970's, **wall bracing** using wall lining materials (plasterboard, plywood, hardboard and fibre cement etc) as the brace may have been used. Where wall linings are stripped, temporary diagonal timber braces (70x35 pine) at 30° to 60° should be nailed to the top plate, bottom plate and studs to each wall to maintain the houses bracing strength prior to re-instatement of permanent bracing and wall lining.

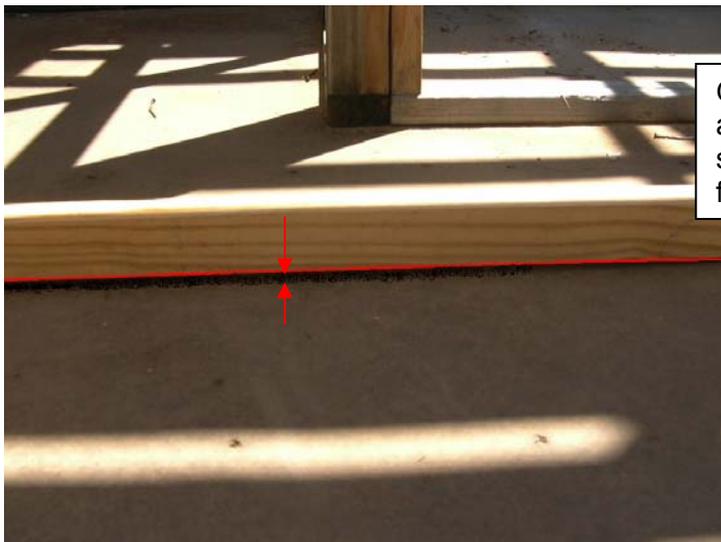
Gap between straight edge and floor indicates edge swelling in particleboard flooring

Allow the particleboard flooring a minimum of 4 months to dry out before re-assessing and any rectification that may be required. As a guide only, it is suggested that if sheet edges have swollen more than 5mm (i.e. would need to be sanded back by 5mm or more to get a flat floor) then the structural adequacy of the flooring has been compromised and needs rectification by either replacement or installation of a new structural floor over the existing particleboard.
